# Castle Drogo - Stakeholder update September 2015

## Phase 2 approaching completion

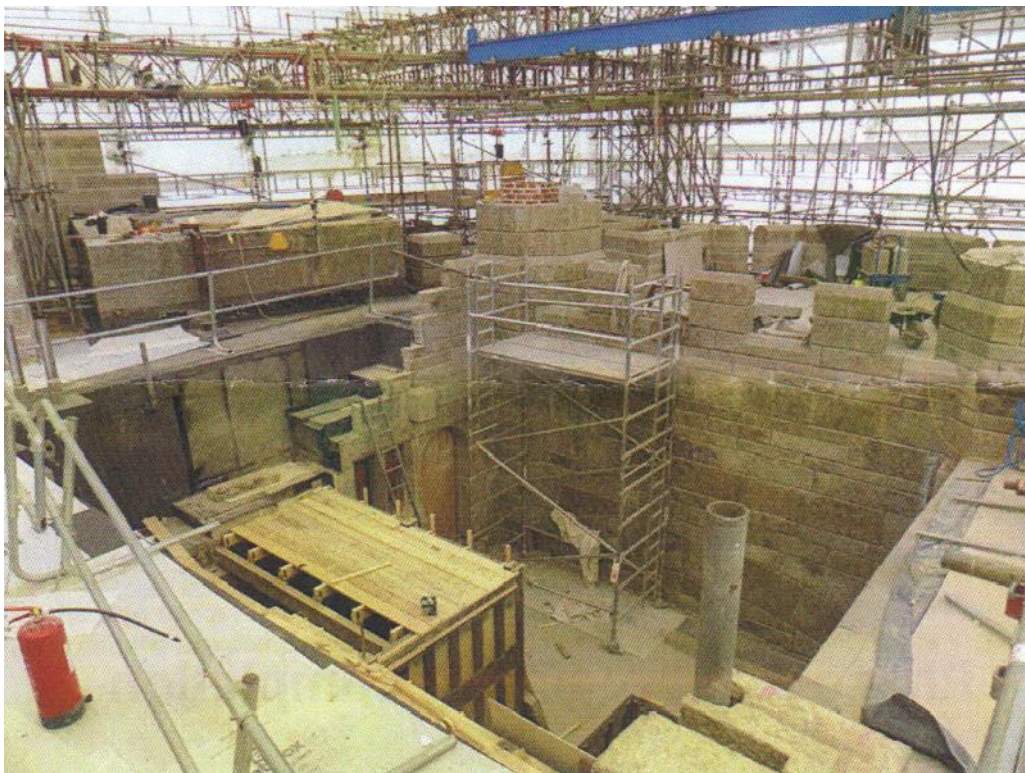
The rebuild of the central tower is almost complete and most of the parapets are now reinstated. The scaffolding in this section will start to be dismantled in October and this section will be fully revealed in November.

Central Tower Rebuild

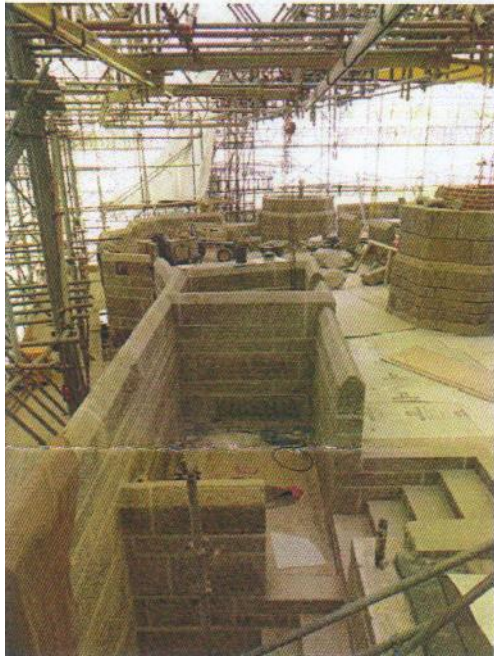
As the photos below show the level of complexity in some sections of the roof -these show the east side of the central tower - the setting out and rebuilding needed is complex and time consuming. The number of level changes, different parapet heights and the complexities of the waterproofing solution apply across the roof but are amplified in a small area such as this.

Parapets rebuilt on the central tower
