# Castle Drogo - Stakeholder update September 2015

## Phase 2 approaching completion

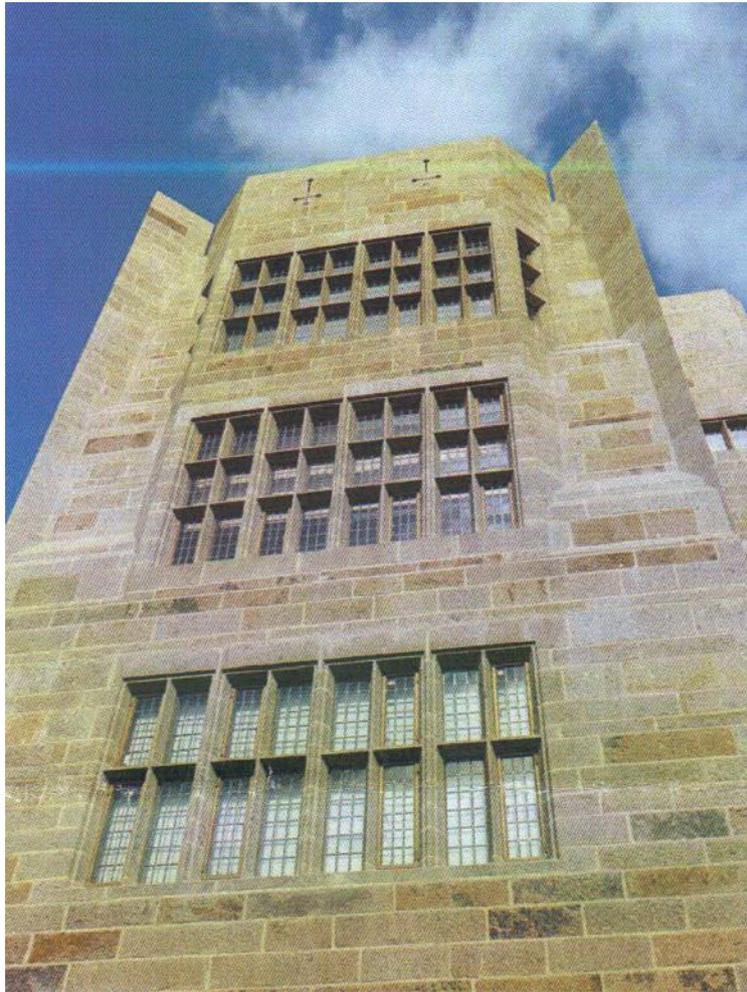
South Elevation Sparkling

Work is rapidly coming towards a close in phase 2. The south wing has already had scaffolding removed and is looking great as the photos show. The windows sparkle in the sun - yes we do get some on Dartmoor occasionally - and already the rooms at the south end feel noticeably drier.

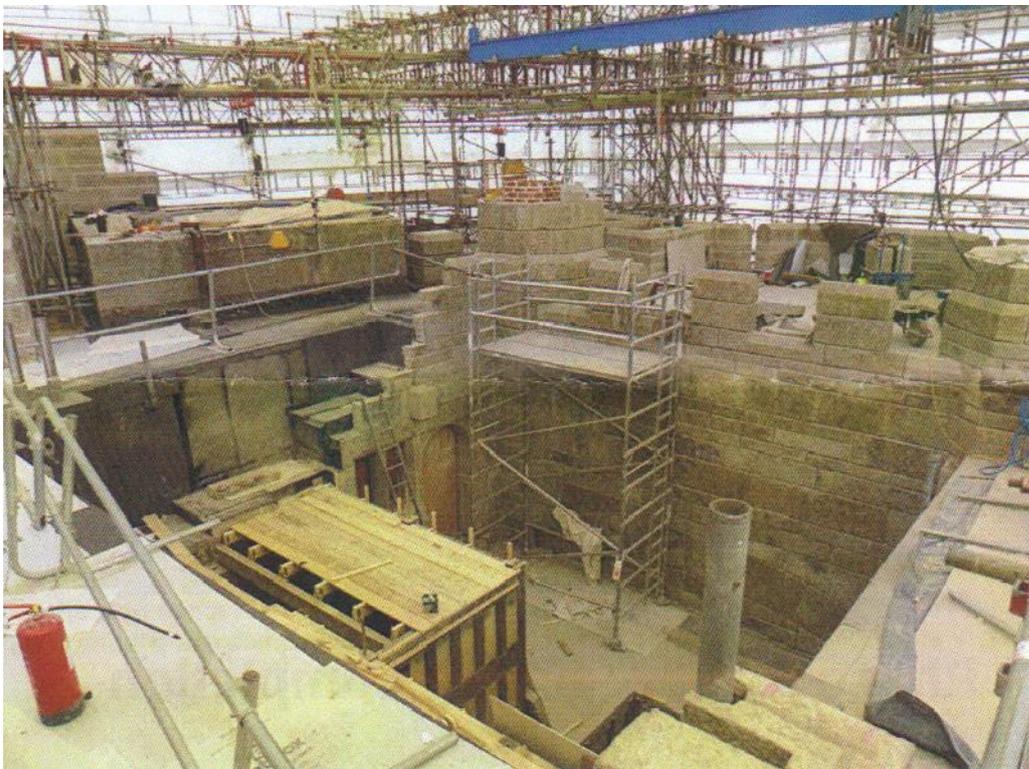
The rebuild of the central tower is almost complete and most of the parapets are now reinstated. The scaffolding in this section will start to be dismantled in October and this section will be fully revealed in November.

Central Tower Rebuild

The roofs around the lower sections of the central lower have to be tackled particularly carefully due to the additional risk of fire around the timber framed section. This area will be completed in the next few weeks with these sections being covered in lead sheet as it was previously, the only part of the building with a different roof construction from the remainder of the roof areas.

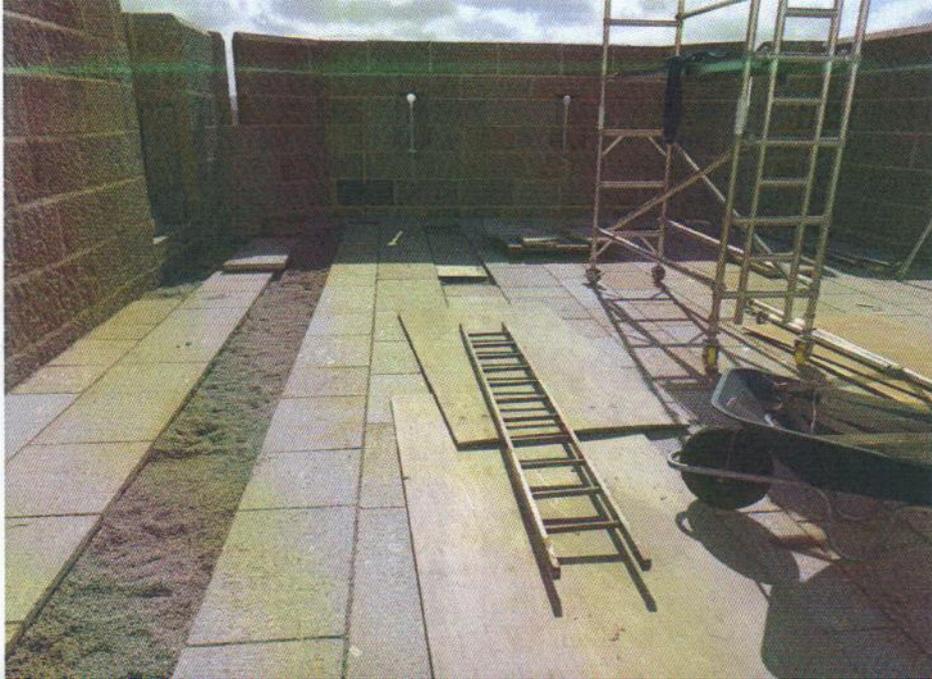
More widely the recovering of the main roof areas is almost complete. The Bauder membrane is in place over 95% of the roof and in many areas the construction above is also now in place. On the south wing the insulation, drainage layer and

paving are well advanced and the reinstatement of the original architectural vision already looks superb and will be even better when it is completed.

South Wing Roof being paved

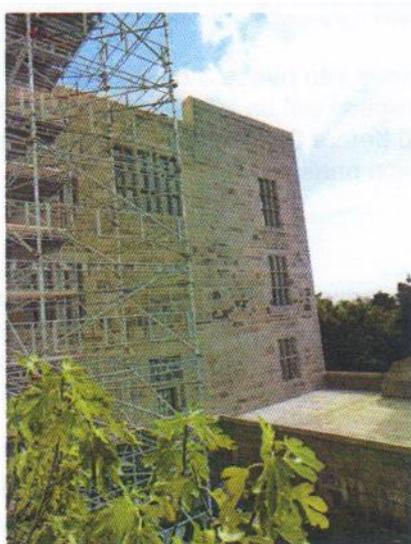
South Wing Roof after scaffolding was removed

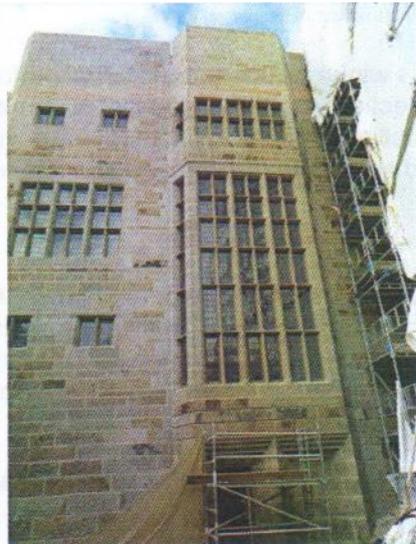
Almost all of the windows removed in the phase 2 works are now reinstated. As mentioned above the mastic sealant is now 100% successful and the windows themselves have been completely overhauled and repaired as well as UV film being applied to protect the interiors and collection from harmful UV light.

East Window

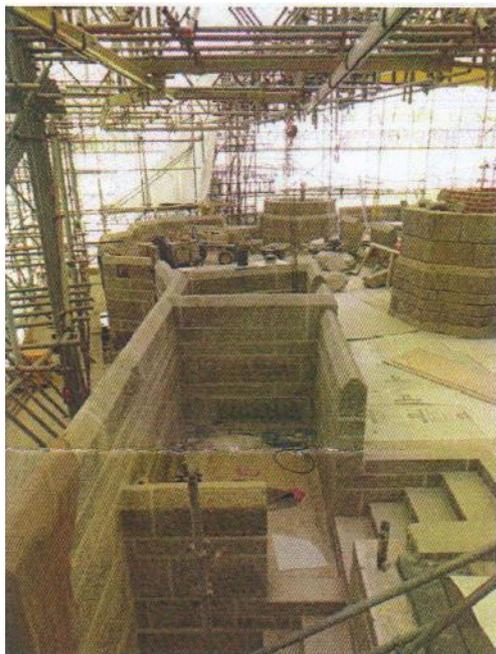
As the photos below show the level of complexity in some sections of the roof -these show the east side of the central tower - the setting out and rebuilding needed is complex and time consuming. The number of level changes, different parapet heights and the complexities of the waterproofing solution apply across the roof but are amplified in a small area such as this.

Parapets rebuilt on the central tower

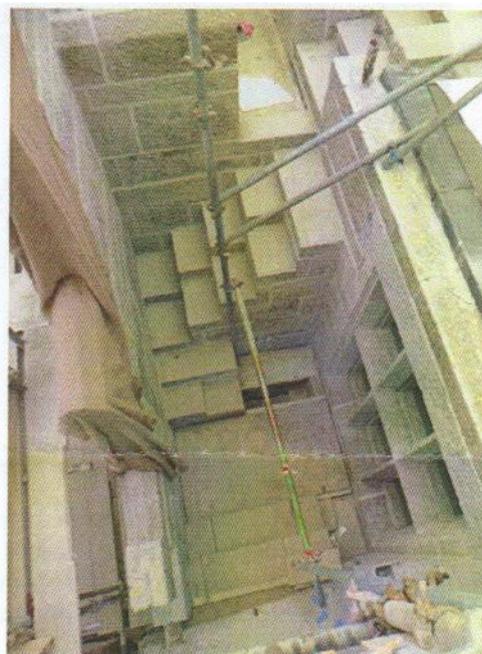
Complex geometry on the east side of the central tower

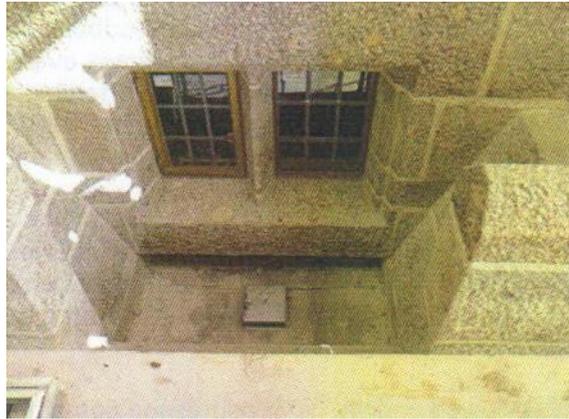
Our fundraising efforts continue and a number of individual donations are much appreciated. One of the windows recently completed above the entrance door of the castle was specifically sponsored by a Charitable Trust. We are still actively seeking further support and our fundraising efforts continue.

Repaired window above the front door
